In-Situ Subsurface Coating of Corroded Steel Sheet Pile Structures

Final Report on Project F08-AR06

Final Report on Project F08-AR-06

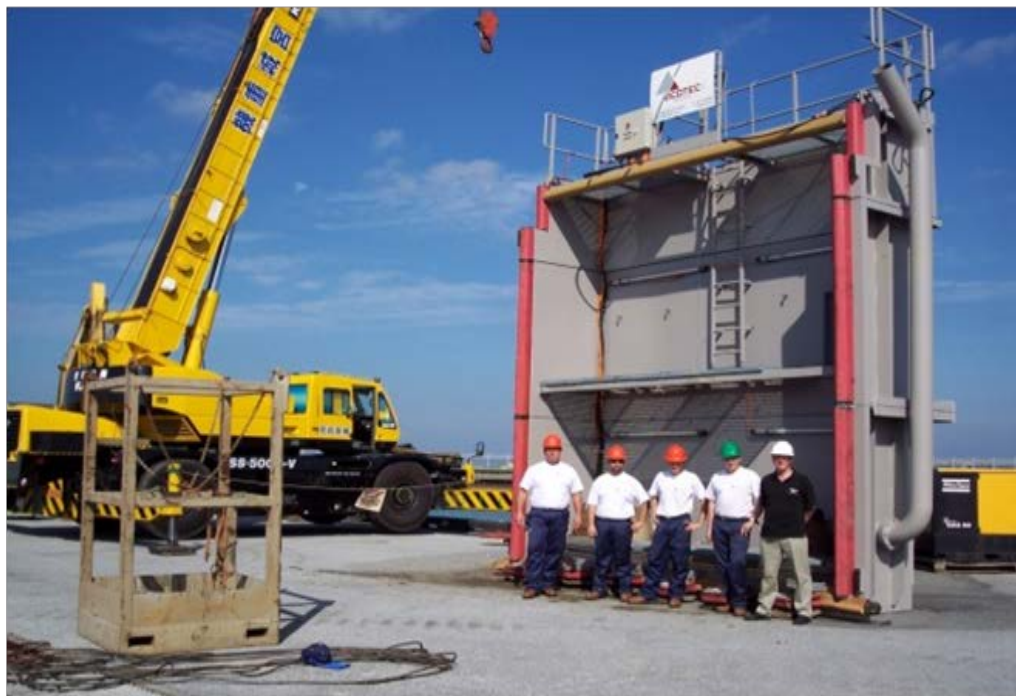
Figure 1. The Acotec Pacific Flyer limpet cofferdam selected for the demonstration.

The limpet cofferdam is a highly specialized technology in terms of system design and requirements for safe and effective operation. In basic terms, it is an open-top, multistory enclosure designed to be rapidly attached to the face of sheet pile structure and pumped dry to provide a safe workspace for structural maintenance and repair of corrosion damage. Specifically, the limpet cofferdam provides dry access to structural surfaces below the low-water level.

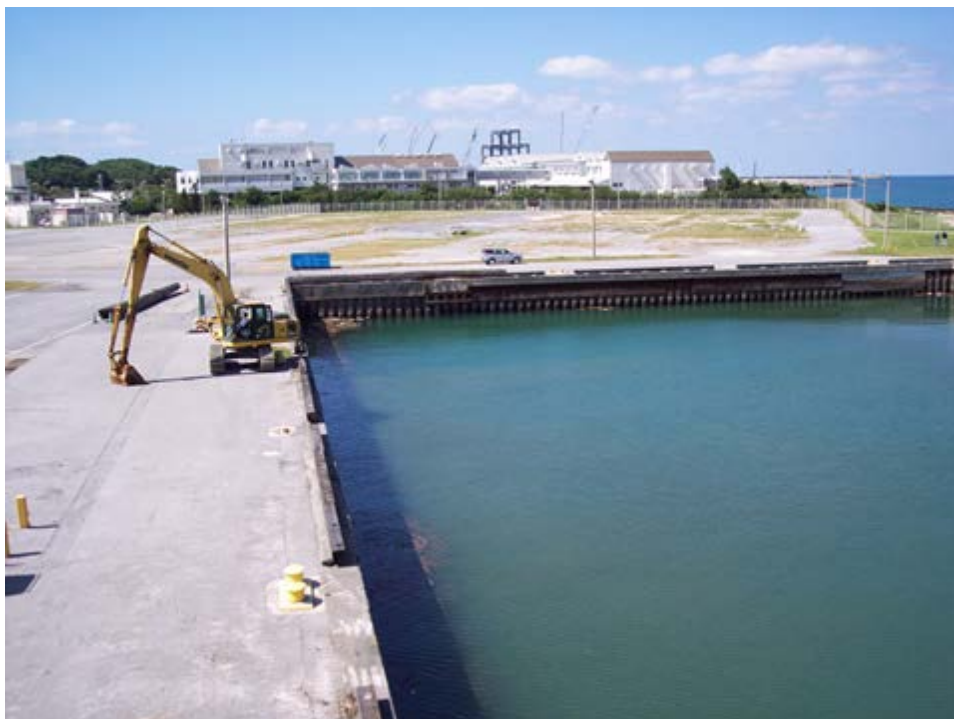
Figure 2. Sheet pile wall at Port Naha, Okinawa, Japan.

The demonstration sheet pile wall is located at Port Naha, Okinawa, Japan (Figure 2). The condition of the piling and the extent of surface cleaning and repairs required were unknown at the onset of the project. Similarly, estimating the cost and time requirements to perform the work were difficult before deployment of the cofferdam. Cleaning and repairs significantly contributed to project duration and cost.

The hot-rolled structural steel sheet piles were installed in 1950s. The sheet pile was manufactured in Japan. Metallurgical reports were not available. No corrosion-prevention methods were previously applied.

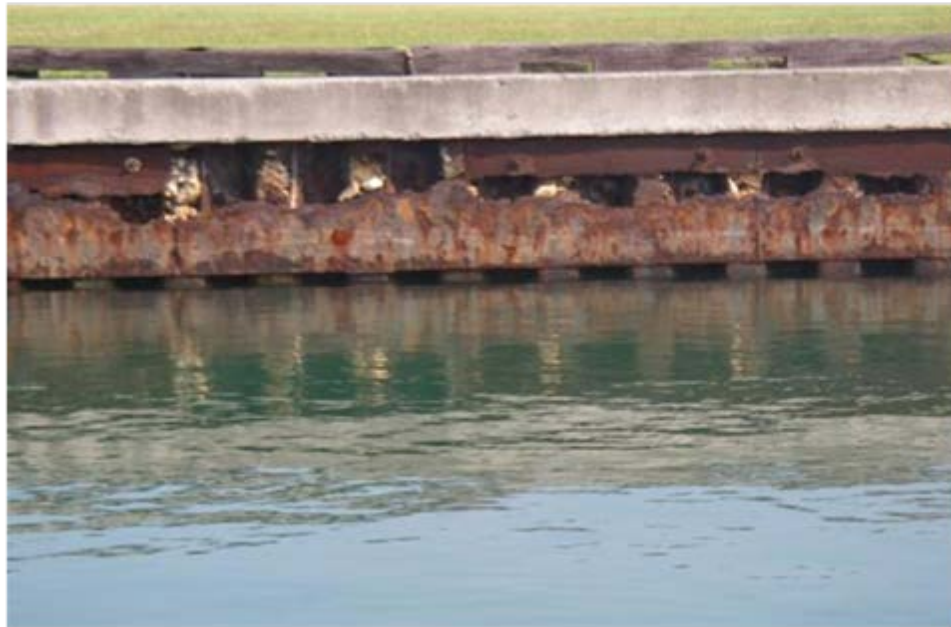
Figure 3. Earlier repairs to sheet pile wall.

Earlier methods to repair the sheet pile walls included the addition of steel plates and concrete (Figure 3). Noncoated steel plating was bolted over damaged sections, but over time those too corroded heavily, lost material thickness, and perforated.

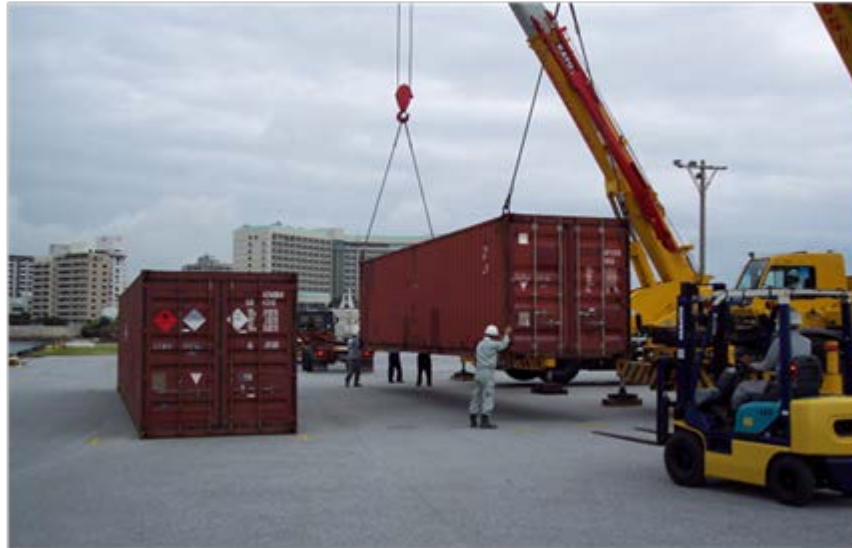
Figure 5. Unloading limpet cofferdam from containers.

The limpet cofferdam and all auxiliary equipment were delivered in two 40-foot shipping containers (Figure 4 and Figure 5). The staging area for the limpet cofferdam was approximately 130 x 65 ft (40 x 20 m) (Figure 6).

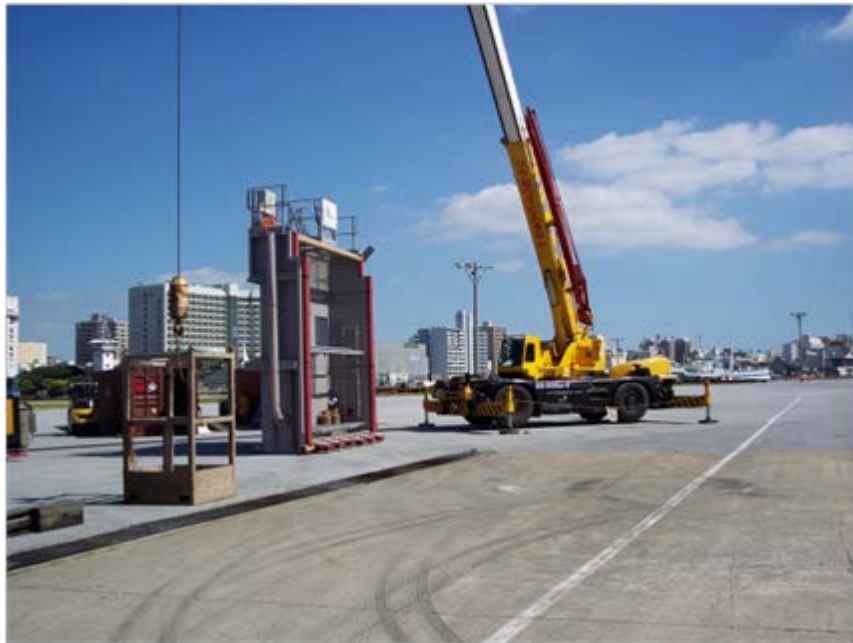
Figure 7. Assembling the limpet cofferdam.

The contractor was able to assemble the limpet in 2 days (Figure 7). The contractor did not have to make any modifications. The limpet satisfied all environmental and safety regulations. Initial deployment and safety training began on the third day after the equipment arrived.

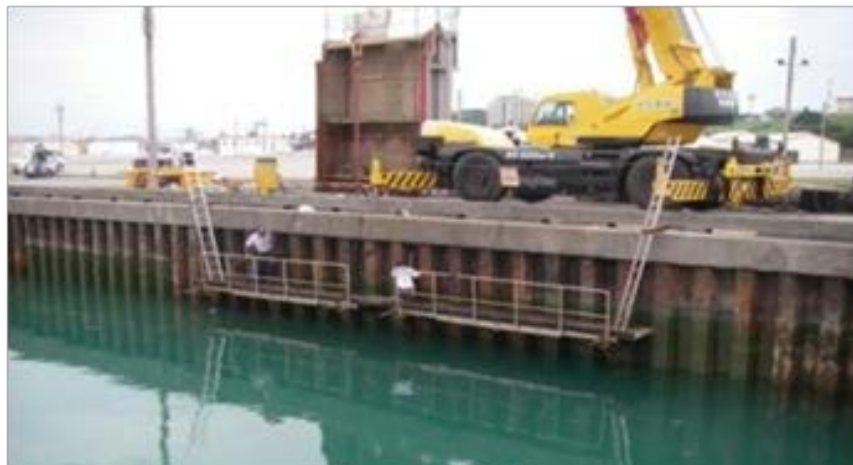
Figure 8. Overwater working platforms.

The contractor deployed two swing platforms for overwater work and the one limpet cofferdam for underwater work. The platforms and cofferdam are shown in Figure 8 and Figure 9. The underwater part of the work from the cofferdam went smoothly due to conditions inside the cofferdam being highly suitable for the work (i.e., lighting, shielding from the elements, floor elevation). The cofferdam was dewatered down to 15 ft (4.6 meters) below the concrete cap.

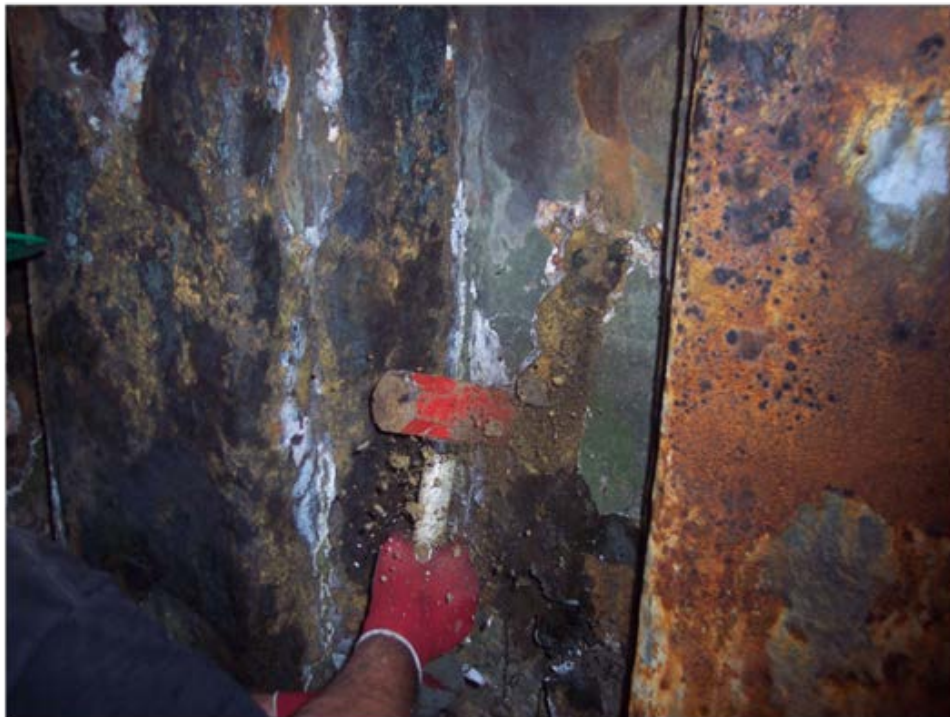
Figure 10. Manual removal of corrosion products.

The team had to remove thick layers of amorphous rust and marine fouling. The work was time-consuming and labor-intensive. The 4,350 psi (300 bar) pressure washer was not powerful enough to remove the thick solid layers, so mechanical impact was required. Workers used hammers and pneumatic tools to remove thick layers of corrosion products as shown in Figure 10 and Figure 11. All debris was collected in the sump of the cofferdam.

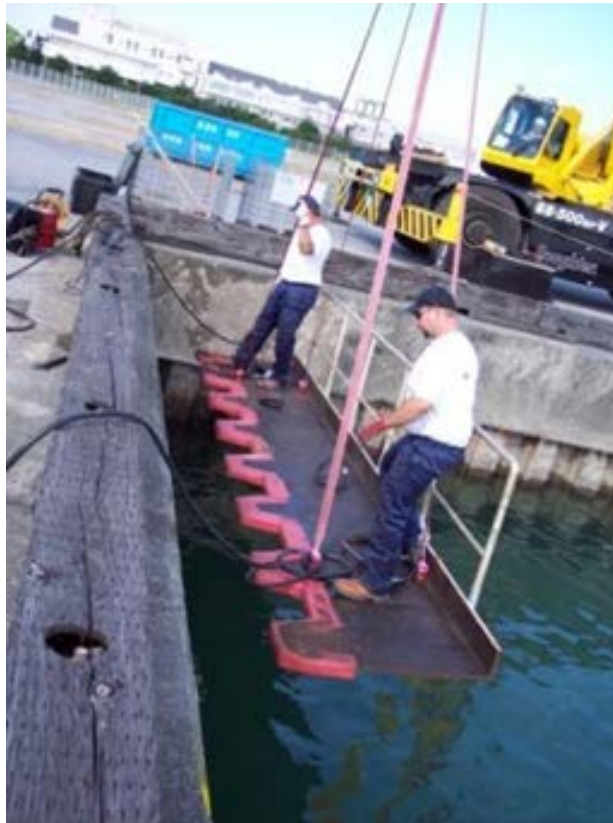
Figure 12. Platform for overwater work.

The contractor installed two work platforms at low tide. The platform edge was designed with a profile to match that of the pilings (see Figure 12) in order to contain debris created during repair and surface preparation. Brackets were welded to the out-pans of the piles to support the platforms, as shown in Figure 13.

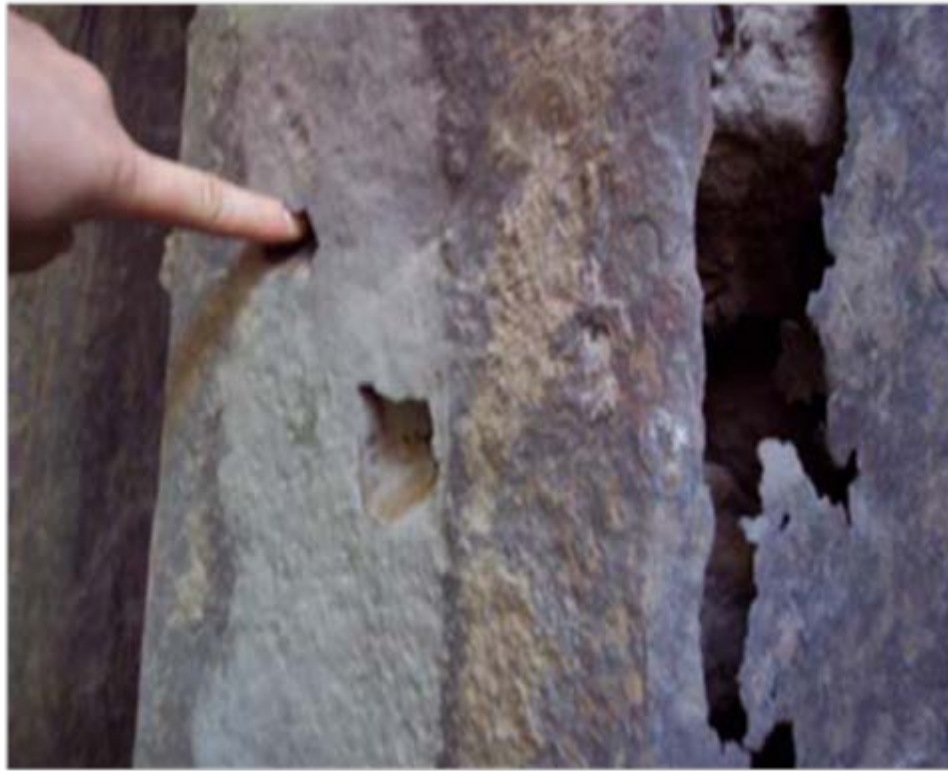
Figure 14. Corrosion in the atmospheric zone.

After manual and mechanical removal of loose debris and corrosion products, workers used abrasive blasting equipment to remove the more tightly adhering corrosion products. Inspection after the initial sheet pile wall cleaning revealed extensive perforations and loss of steel in a 3 ft (1.0 m) band above the waterline. The condition is shown in Figure 14.

Each pile was heavily corroded and there were perforations in the area between the splash zone and the underside of the concrete capping beam. All of the holes were situated at the corners and webs of the out-pans in a band of approximately 2.6 ft (0.8 m) under the capping beam. The steel of the in-pan was only perforated in a few places, and remaining steel was on average about half the original thickness, or approximately 0.4 in. (10 mm). The remaining steel was thick enough to dry weld reinforcing plates to it. Small isolated holes were plugged with a special cement suitable for the purpose.

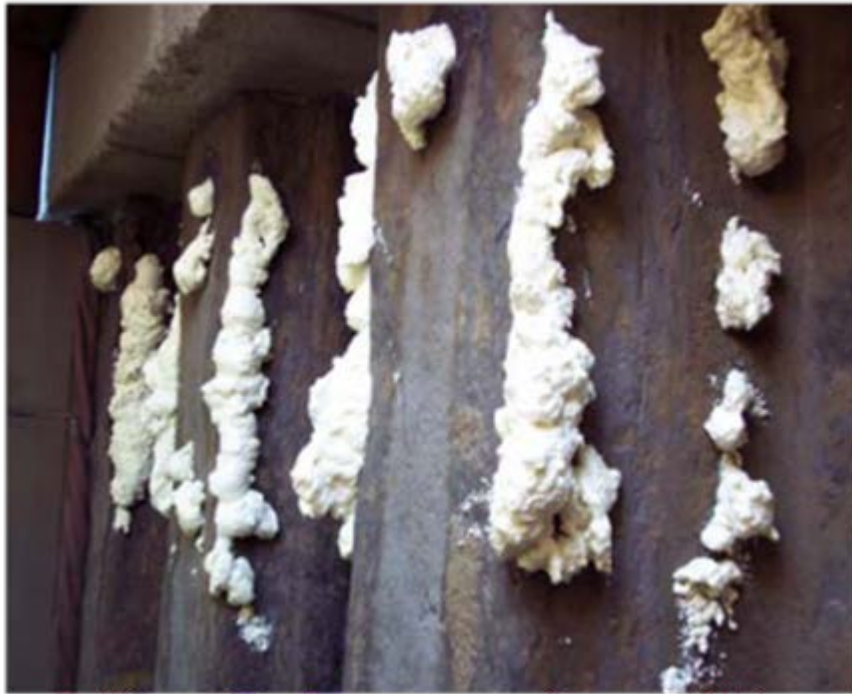
Figure 15. Polyurethane injection into voids behind piles above the waterline.

Much backfill had fallen out. Larger stones remained in place. The scope of work did not include refilling voids behind the piles, but the contractor injected polyurethane foam in lieu of replacing backfill (Figure 15). After the perforations were filled, the contractor filled the surface of the piles with proprietary cement, as shown in Figure 16. At the conclusion of this work, the piles (Figure 17) were watertight.

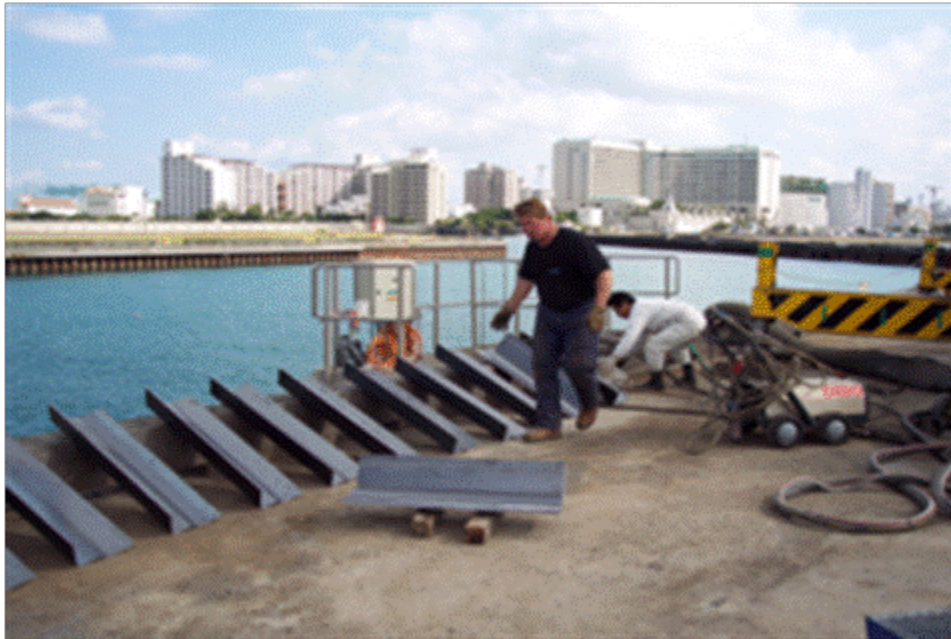
Figure 18. Doubling plates.

The contractor prepared 100 plates 0.25 in. (6 mm) thick and 3.3 ft (1 m) high to reconstruct 50 piles. Figure 18 shows the material staged at the site. A local metal shop rolled the plates to fit the original pile as closely as possible. A 3/8 in. (10 mm) hole was drilled in each plate to allow injection of either non-shrink cement grout or epoxy resin in the gap between old and new steel, shown in Figure 19. This was the reason why the perforated piles needed to be made liquid-tight with cement grout or epoxy. Otherwise, the material injected between the old and new steel would be lost behind the old steel.

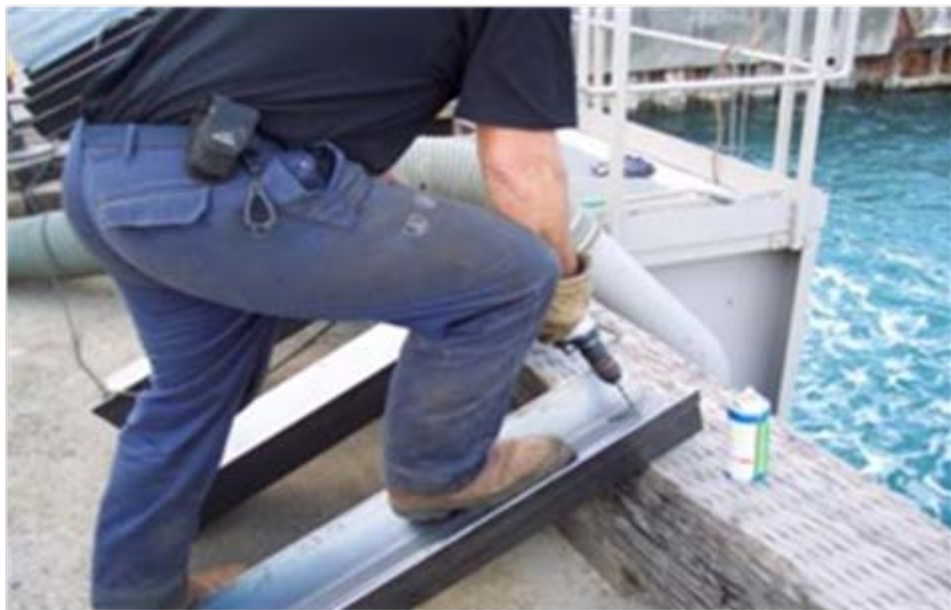
Figure 20. Tack welding plates.

Two workers installed and tack-welded the plates with use of an inverter welding set (welding rods), as shown in Figure 20. A third person finished the welding with a semiautomatic welder using Lincoln Intershield 1.4 mm wire (Figure 21).

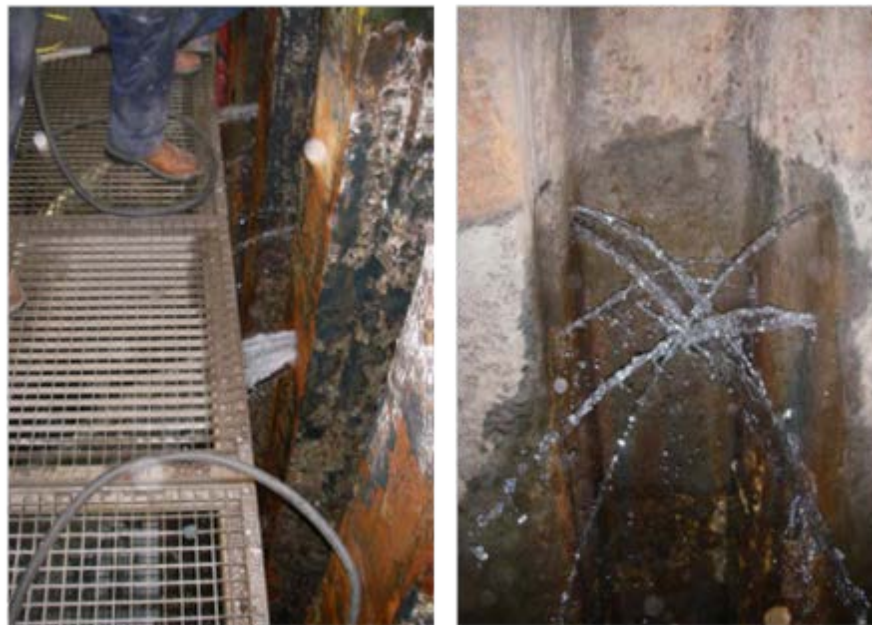
Figure 22. Platform at -11.5 ft (-3.5 m) below surface a (left), and pinhole leaks that appeared after initial surface preparation.

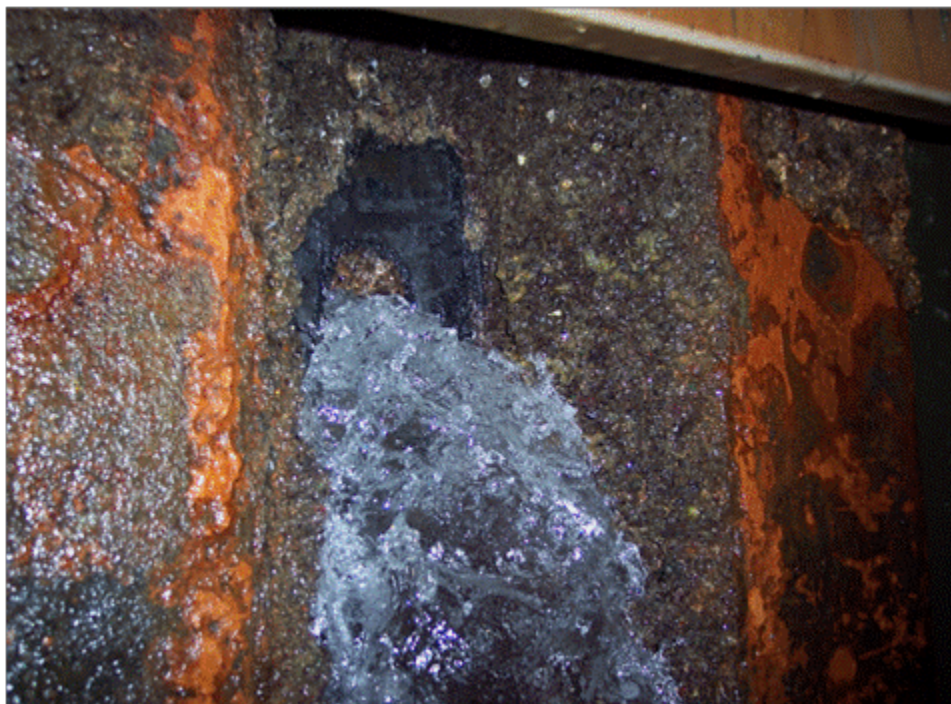
Figure 23. Example hole on out-pan.

Two-inch (50 mm) diameter holes were found at -8 to -11 ft (-2.5 m and -3.5 m). The location of most holes was on the out-pans of each pile, as shown in Figure 23.

These holes were likely made at the time of construction for tie rods. Subsequently, the tie rods were installed on the in-pans, and the holes were left open. Only a few perforations actually caused by corrosion were identified under the waterline. These holes were patch-welded with 8 x 8 x 0.25 in. plates (200 x 200 x 6 mm), as shown in Figure 24.

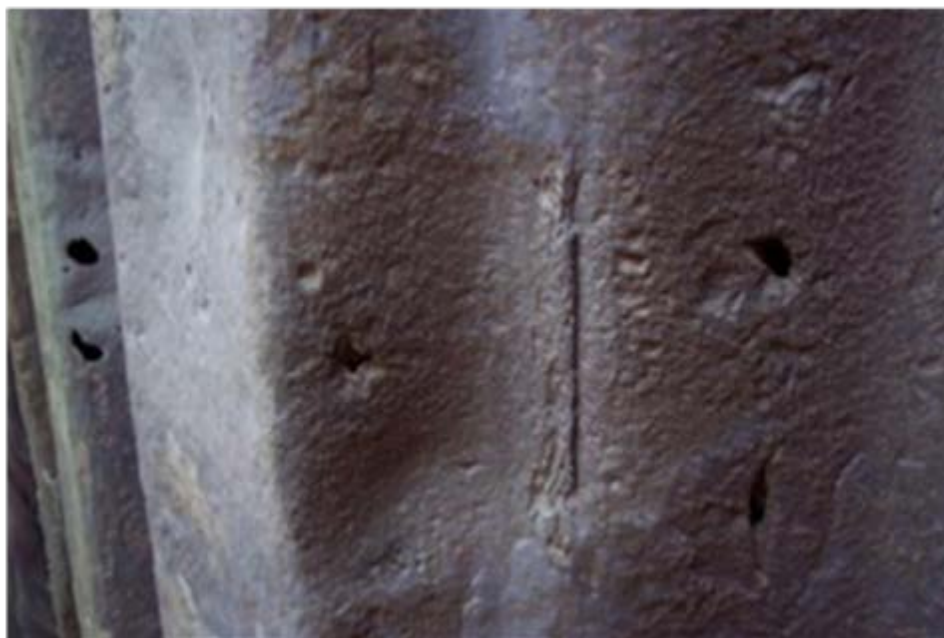
Figure 25. Deep pits in surface-prepared bare steel plating.

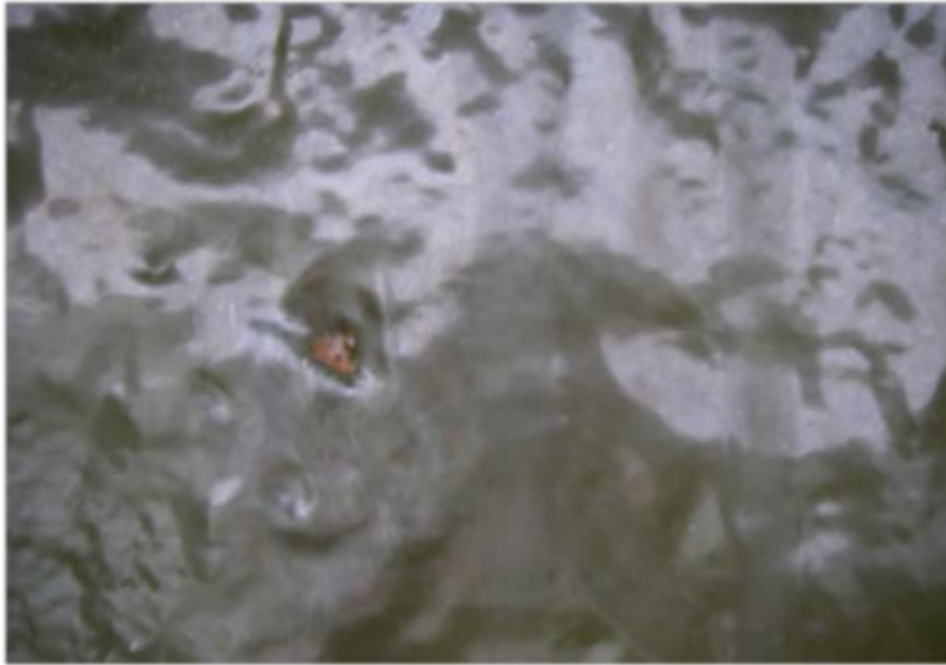
Figure 26. Holiday in coating formed over deep surface pit.

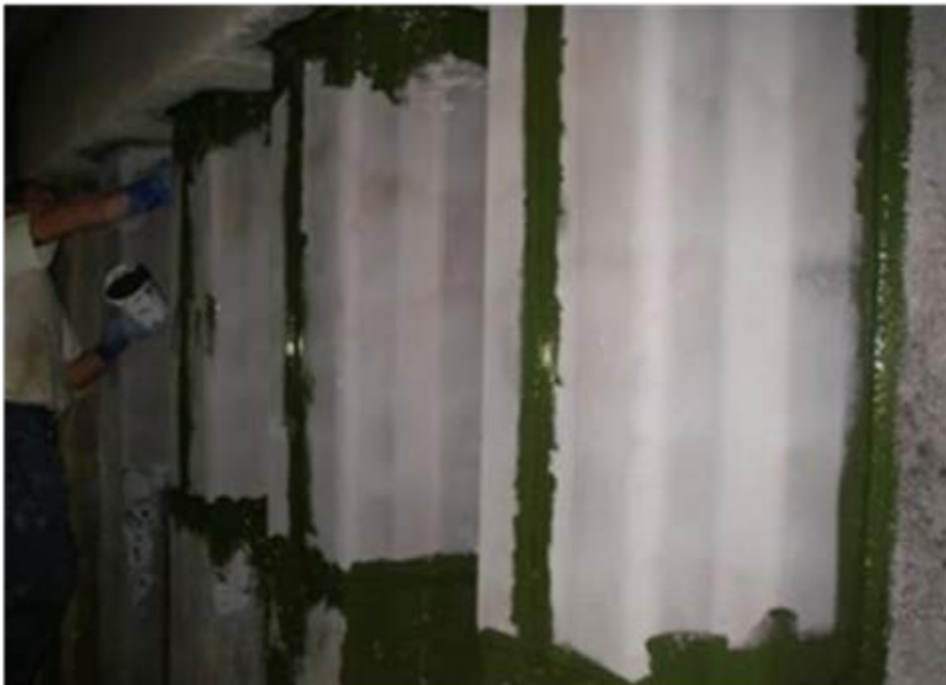
Figure 27. Z pile interlocks treated with Humidur putty and brush-applied variants.

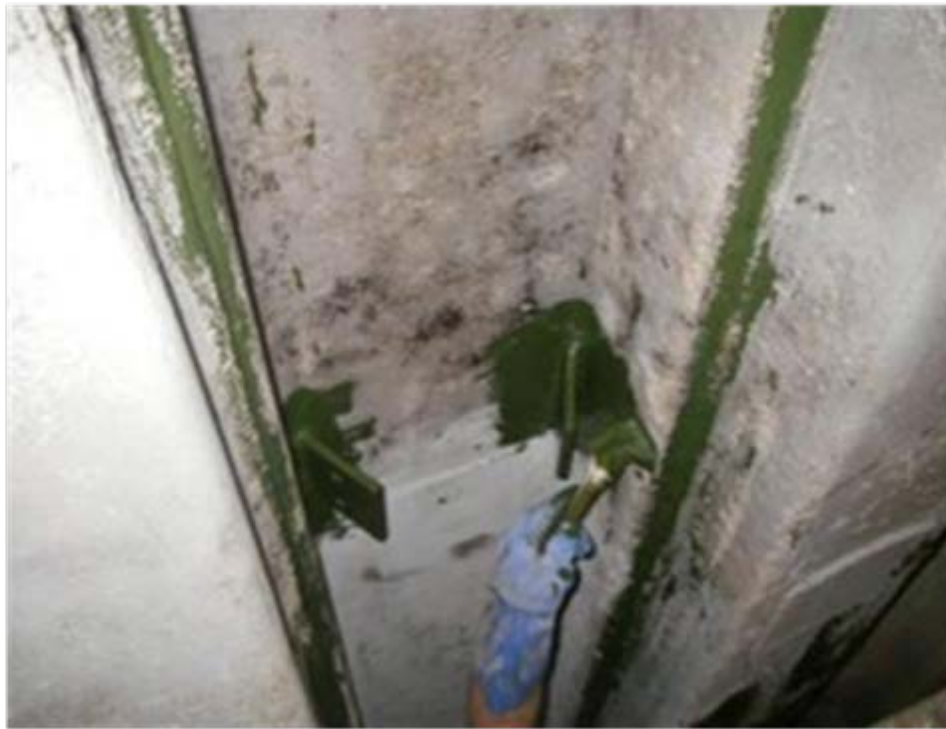
Figure 28. Brush application of Humidur BAML on sharp edges before spray coating.

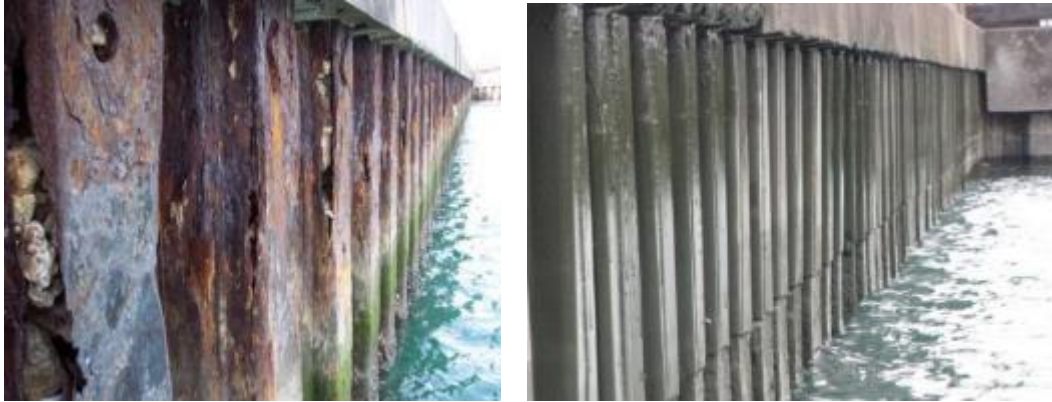
Figure 29. Sheet pile wall before (left) and after renovation (right).

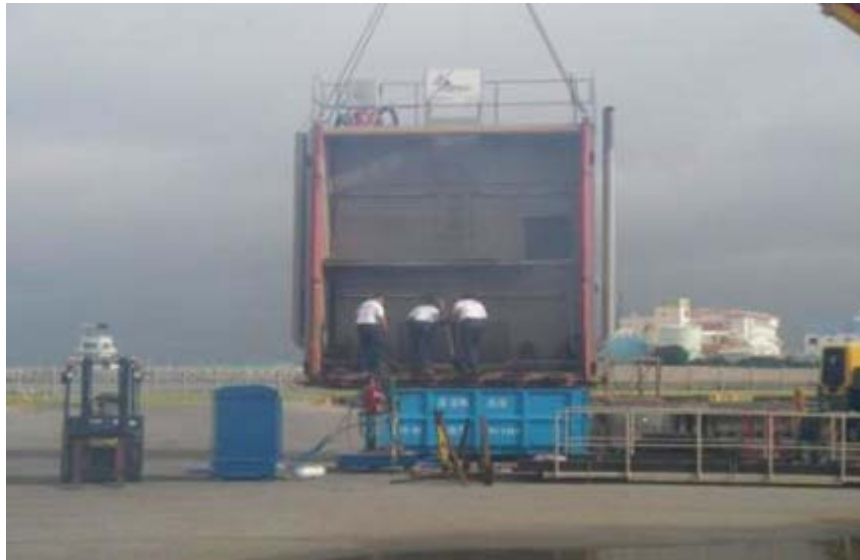
Figure 31. Installation of reference panels.

In order to monitor and test coating performance over time, the contractor installed 24 panels on the underwater face of the sheet pile wall for exposure. Figure 31 shows the contractor installing the reference panels as work was completed for one section of the sheet pile wall.

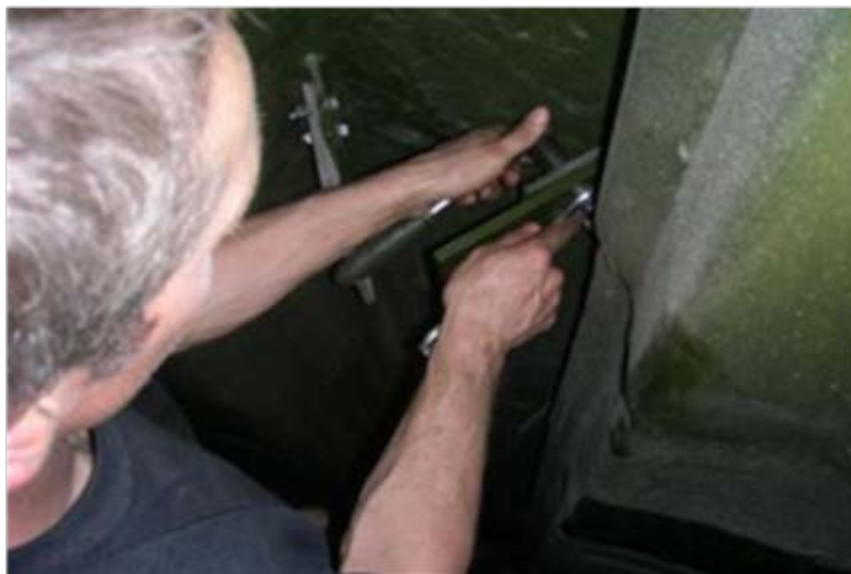
The reference panels were approximately 3 x 9 in. (8 x 23 cm) and fabricated of mild steel. Twelve panels were coated with the amine epoxy coating using the same process that was used to coat the sheet pile on the seawall. The other twelve were installed untreated.

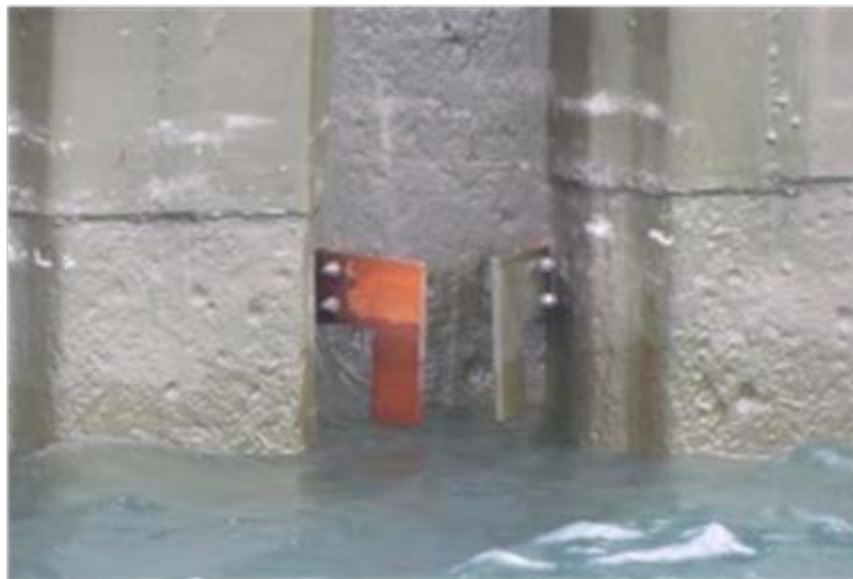
Figure 32. Treated and untreated panels installed on sheet pile wall.

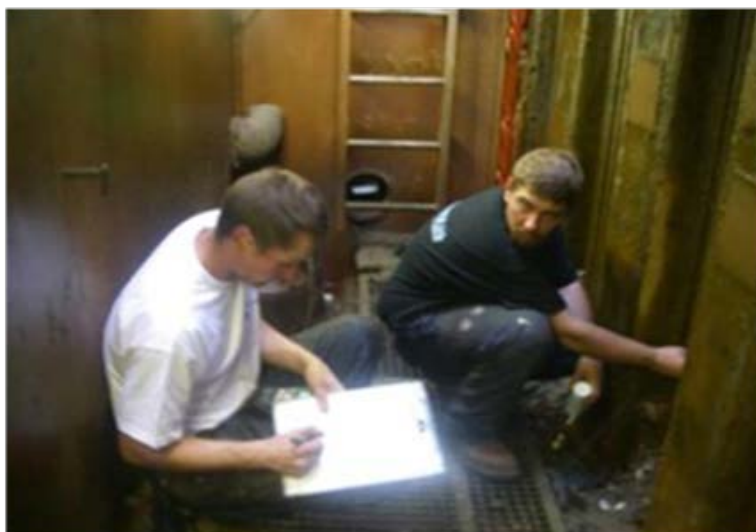
Figure 34. Measuring pit depth.

Each of the 42 measurements was the average of four measurements in a 2 in. (5 cm) diameter area. In total, 2,100 average steel thicknesses were recorded out of 8,400 measurements taken (Figure 33). Locations of deep pits were also identified and measured using the gauge shown in (Figure 34).

Pit impact on residual steel thickness was accounted for by subtracting pit depths that were measured using the gauge shown previously in Figure 34, from ultrasonic thickness measurements of the surrounding steel.

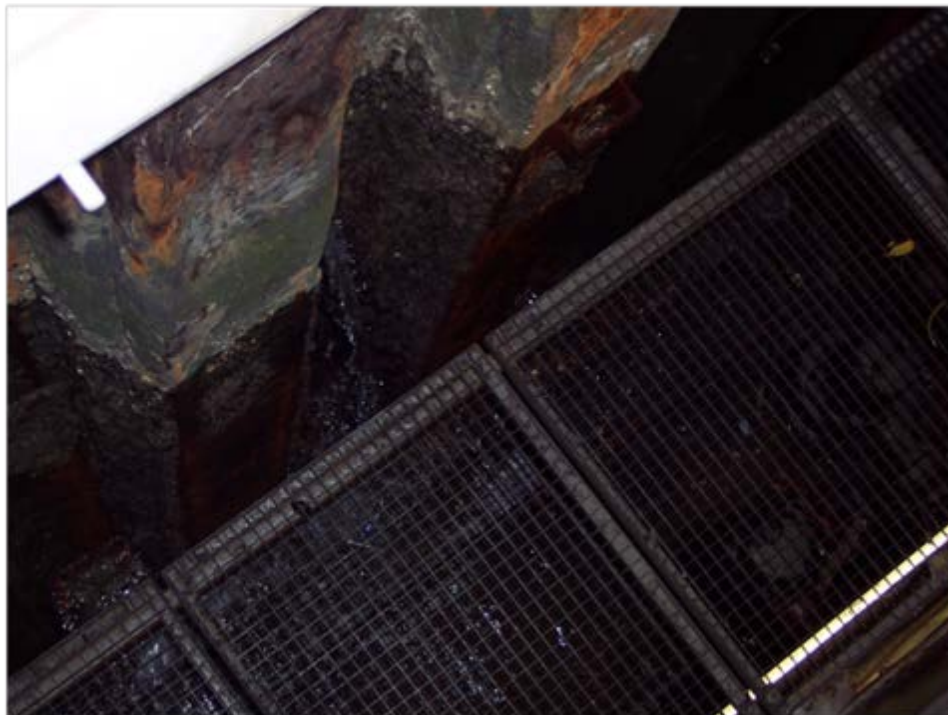
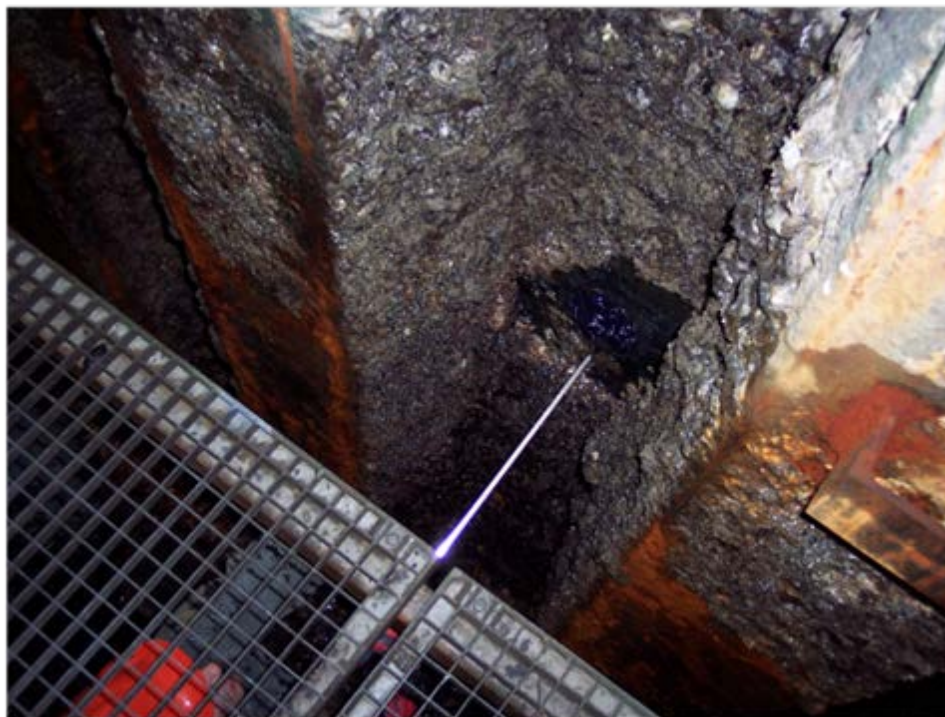
Figure 37. Tidal zone below -5 ft (-1.5 m).

Cleaning revealed a thick layer of amorphous rust more than 0.4 in. (10 mm) thick. The thick rust layer was very difficult to remove. Between -5 ft and -6.5 ft (-1.5 m and -2.0 m), the intact steel underneath was only slightly pitted.

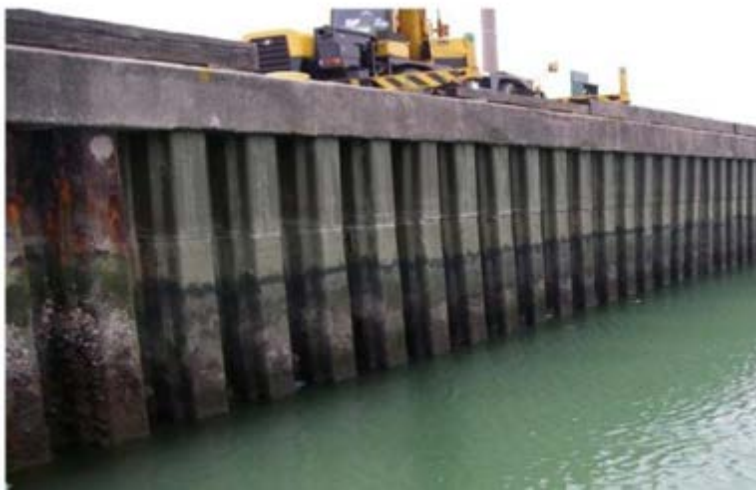
Figure 39. General condition of sheet pile wall 6 months after renovation.

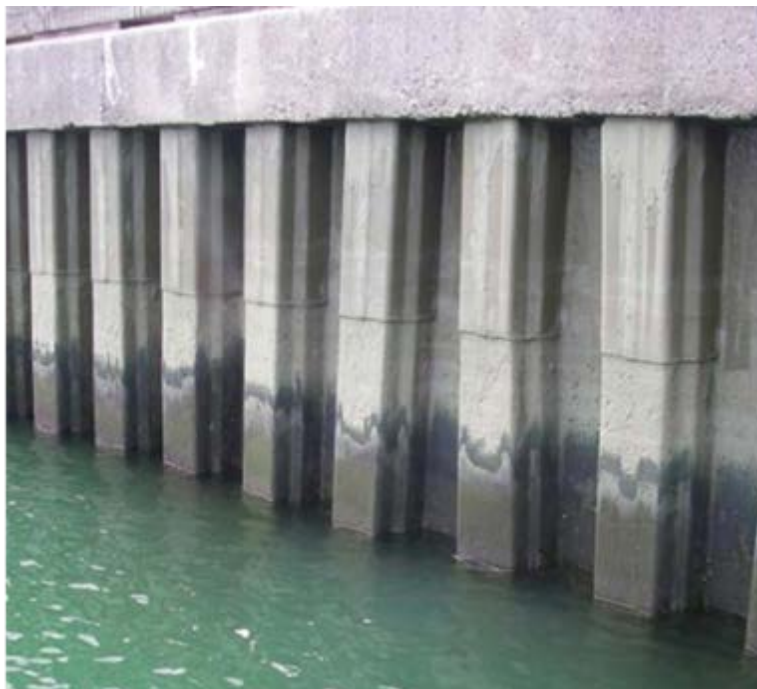
Figure 40. Closer view of completed work after 6 months.

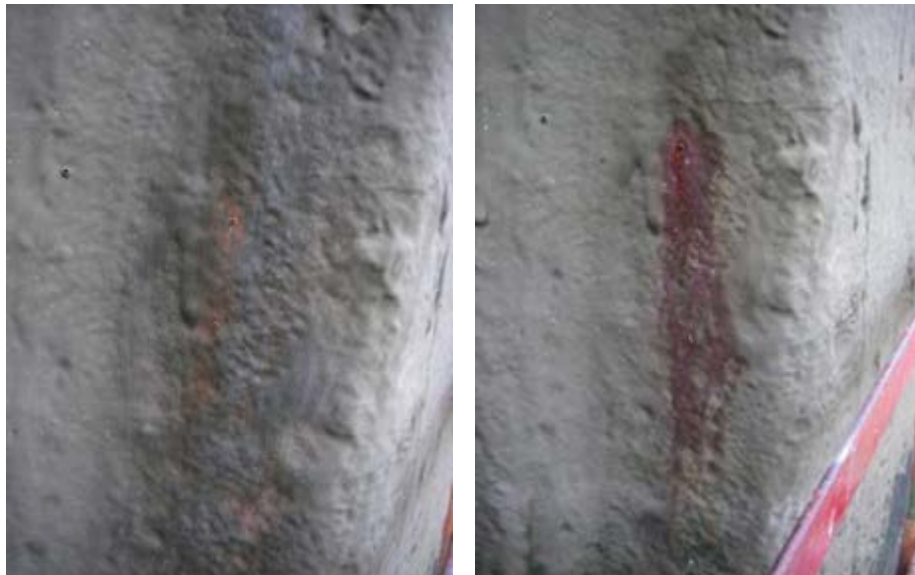
Figure 41. Two small pinholes (left) and rust stain (right).

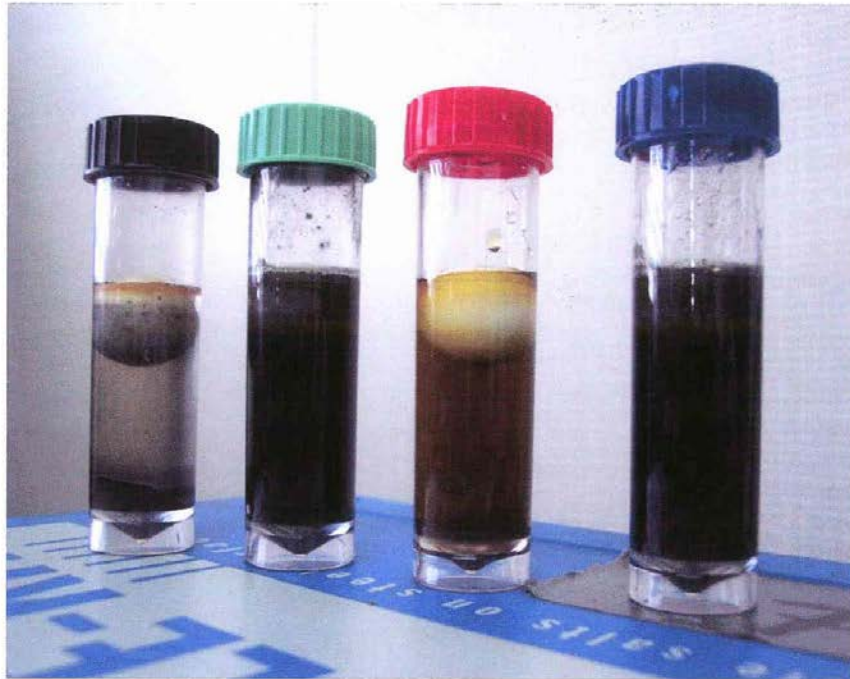
Figure 2: Black substance divided into different test tubes, each searching for a different kind of bacteria

Figure 3: Results of the different test show that different kinds of microbacteriological elements are present (from left to right: sulphate reducing bacteria (black cap) - Biochemical oxygen demand (light blue cap) - Iron related bacteria (red cap) - Acid producing bacteria (purpel cap).

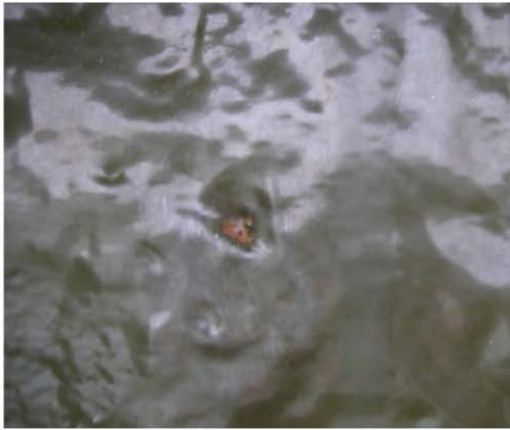
Pile n° 20
Holiday

Some Pictures of small defects and pinholes

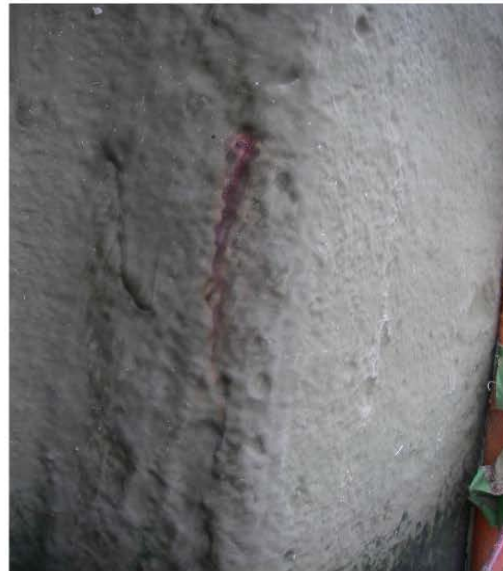
Pile n° 27
One pinhole

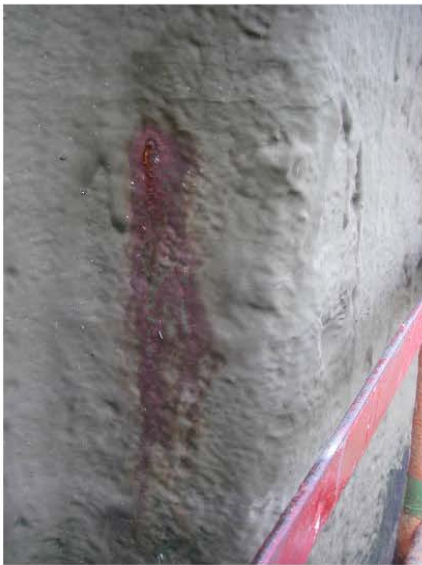
Pile n° 23
Two pinholes

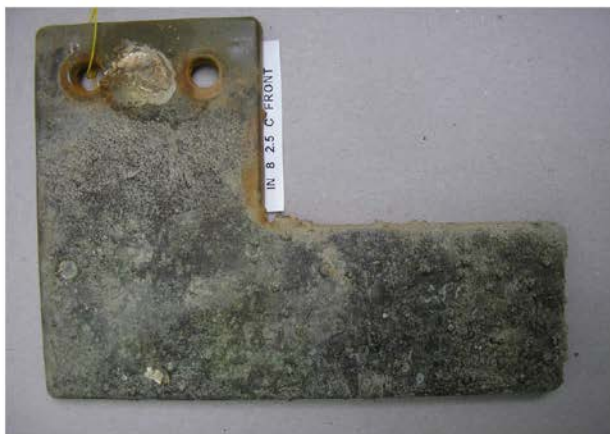
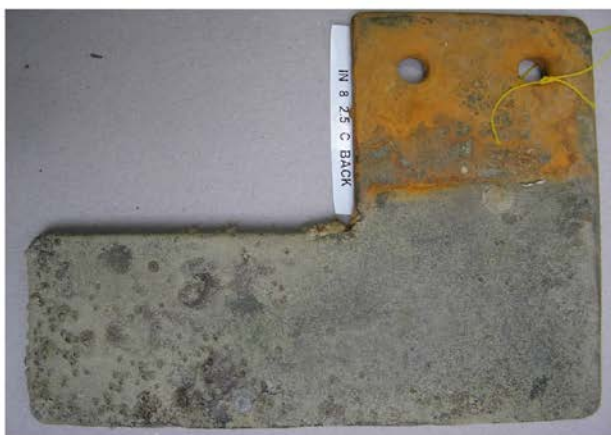
small acorn barnacles are visible , dimensions till 1 cm
One barnacle has a diameter of 2,5 cm
small quantities of algae growth cover the complete surface
rust color is visible at the backside in the fixing area

Coupon Number	ASTM D 714 Evaluation Degree of Blistering		ASTM D 610 Evaluation Degree of Rusting		
	Size	Frequency	Rust Grade	Spot	General Pinpoint
IN 8 - 2.5 C					
Front	10	none	10	none	
Back	10	none	10	none

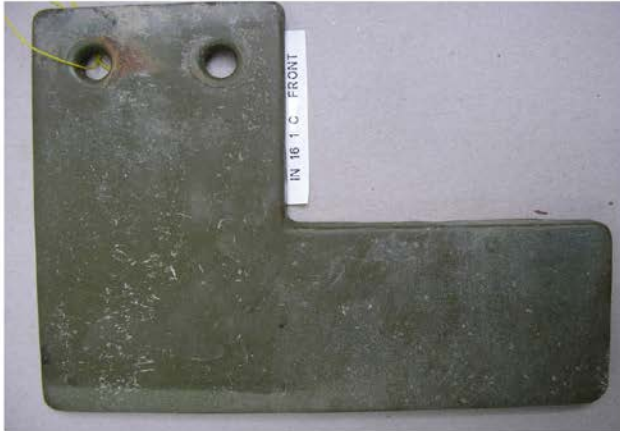
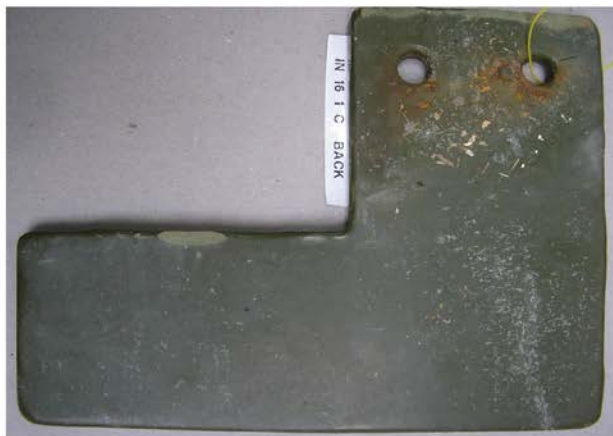
No marine growth on this coupon , only some dirt
rust color is visible at the backside in the fixing area

Coupon Number	ASTM D 714 Evaluation Degree of Blistering		ASTM D 610 Evaluation Degree of Rusting		
	Size	Frequency	Rust Grade	Spot	General Pinpoint
IN 16 - 1 C					
Front	10	none	10	none	
Back	10	none	10	none

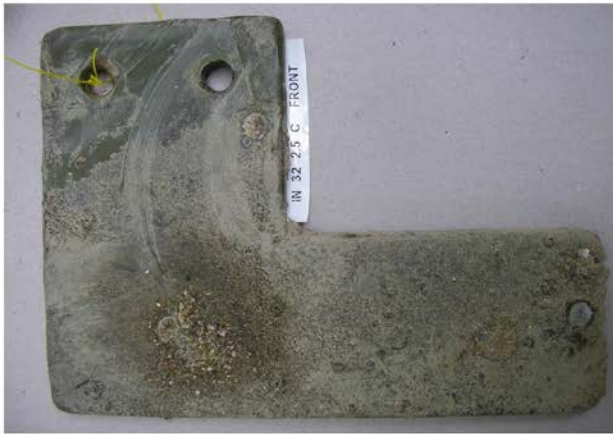
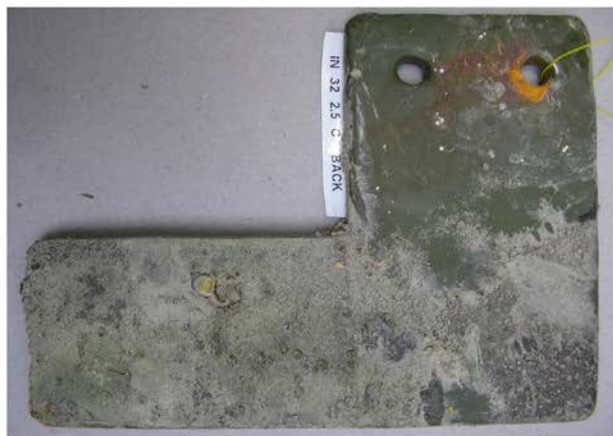
Coupon IN 32 - 2.5 C before cleaning :

small acorn barnacles are visible , dimensions till 1 cm
small quantities of algae growth cover the complete surface
rust color is visible at the backside in the fixing area

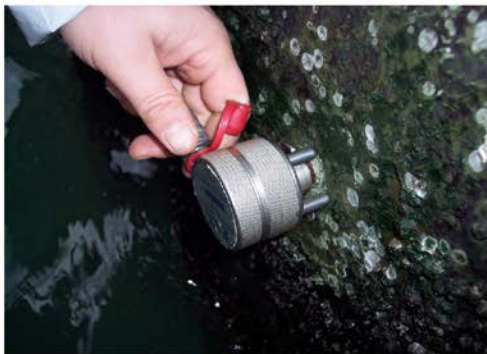
position of dolly

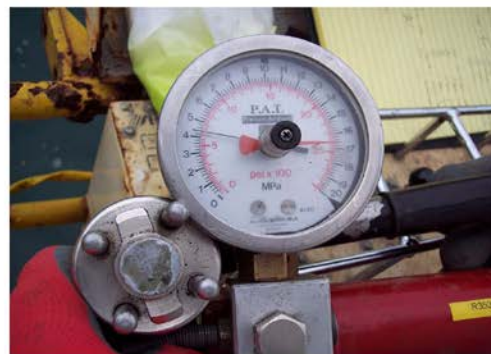
the red pointer give the result of adhesion test

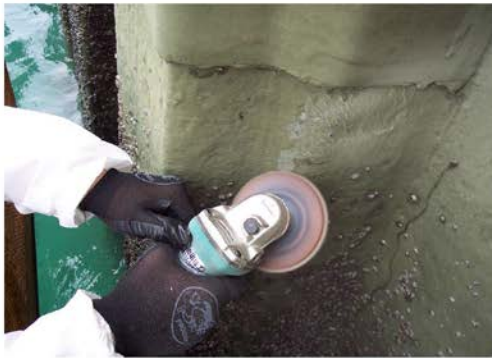
grinding or drilling

The pinholes and minor defects that where found on the first inspection were repaired on December 1st & 2nd, 2009.

And this in following procedure: removal of the pinholes with grinder or by drilling
 clean the area with distilled water and tissue
 further cleaning with acton and dry the area with hot air.
 Touch up with Humidur® PML

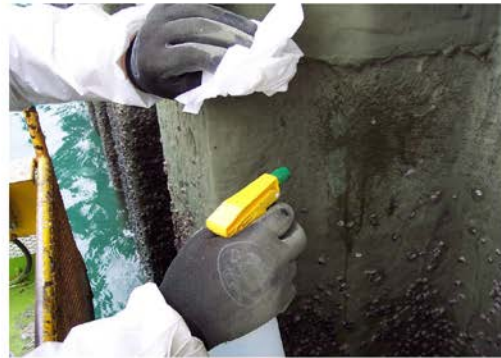
cleaning with distilled water and tissue

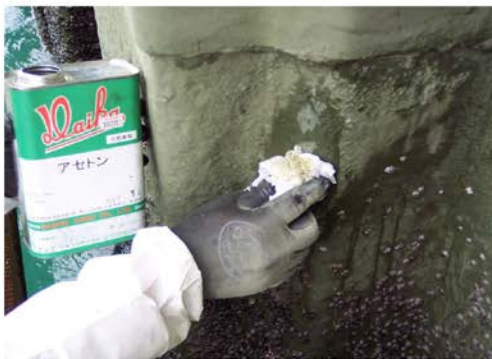
Degreasing with acetone

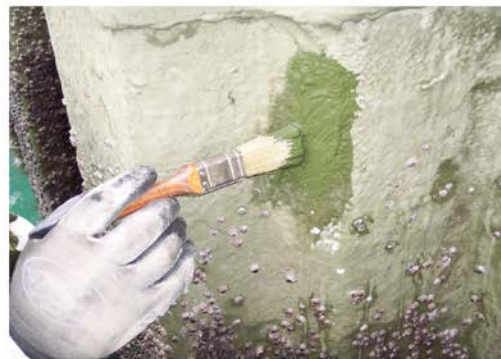
applying the coating
